<b>Project Name:</b> Gold King Mine	<b>Site Location:</b> Silverton, San Juan County, Colorado	<b>Project No.</b> 0001/1408-01
--	---	------------------------------------

## PHOTOGRAPH LOG

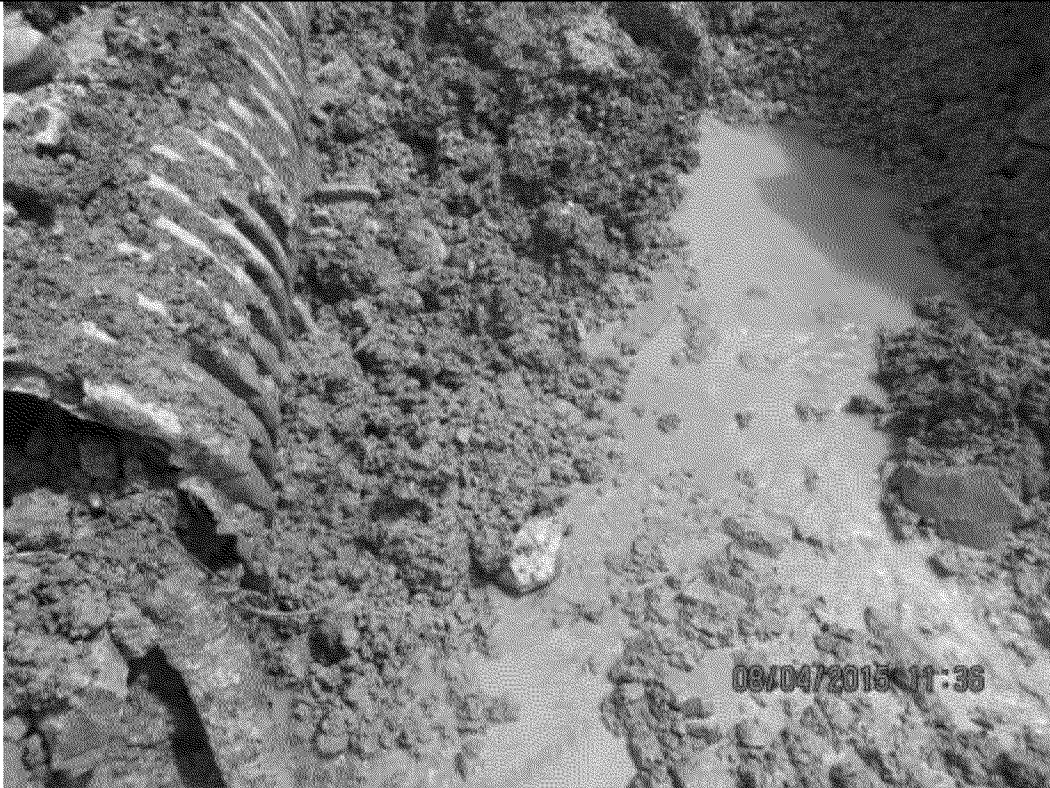
<p><b>Photo No.</b> <b>3</b></p>	<p><b>Date:</b> 08/04/2015</p>

<p><b>Direction Photo Taken:</b></p> <p>Down</p>		
<p><b>Description:</b> Seepage from soil next to piping.</p>		
<p><b>Photo No.</b> <b>4</b></p>	<p><b>Date:</b> 08/04/2015</p>

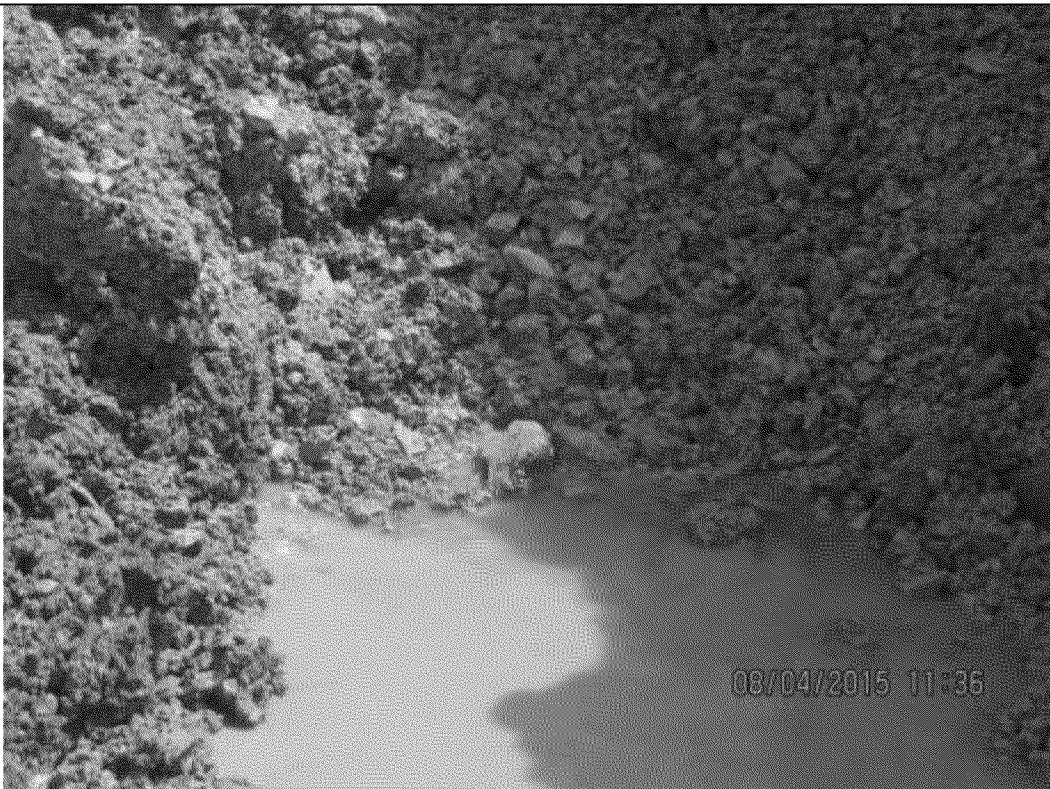
<p><b>Direction Photo Taken:</b></p> <p>Down</p>		
<p><b>Description:</b> Seepage next to the pipe is clear until entering disturbed soil.</p>

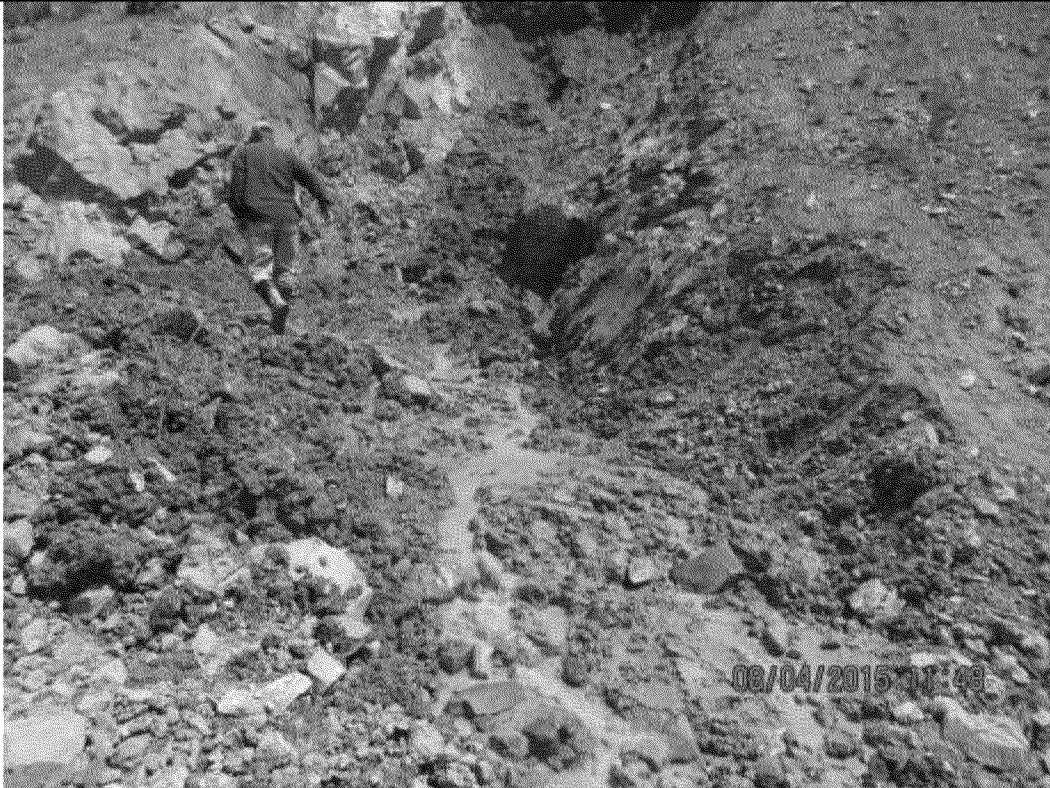
<p><b>Photo No.</b> <b>5</b></p>	<p><b>Date:</b> 08/04/2015</p>

<p><b>Direction Photo Taken:</b></p> <p>North</p>		
<p><b>Description:</b></p> <p>DRMS looking at adit excavation progress.</p>		
<p><b>Photo No.</b> <b>6</b></p>	<p><b>Date:</b> 08/04/2015</p>

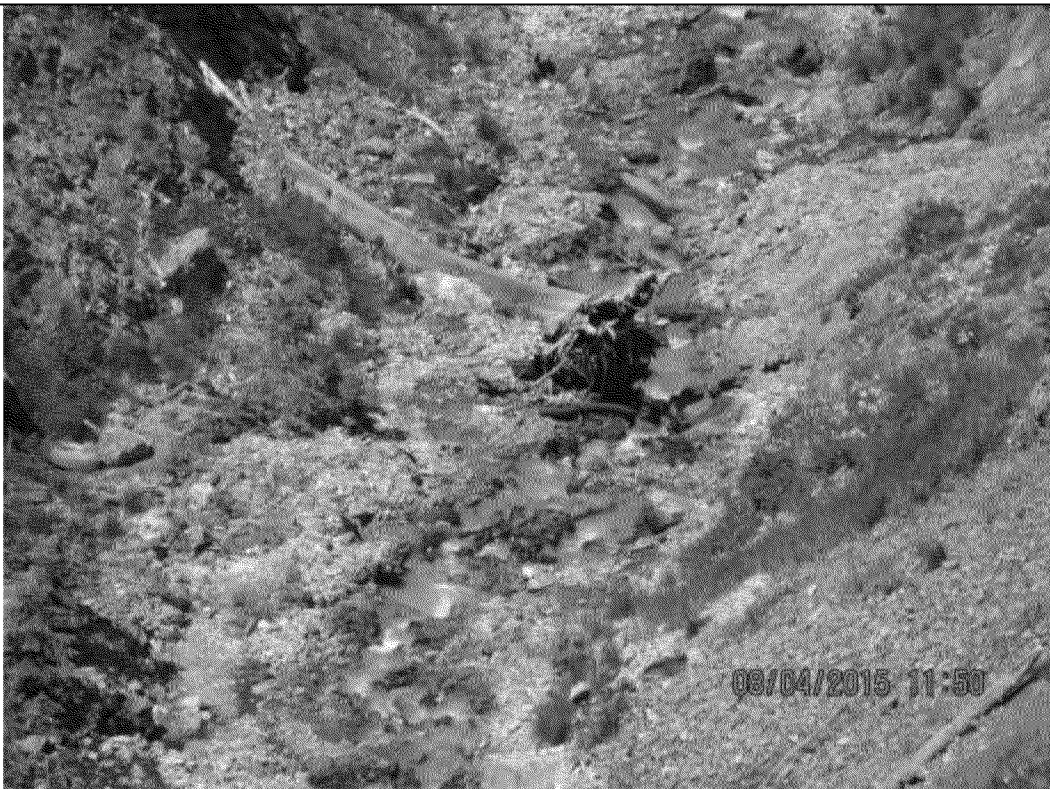
<p><b>Direction Photo Taken:</b></p> <p>West</p>		
<p><b>Description:</b></p> <p>Water minimally murky from disturbed soil and water entering the North Fork from site.</p>

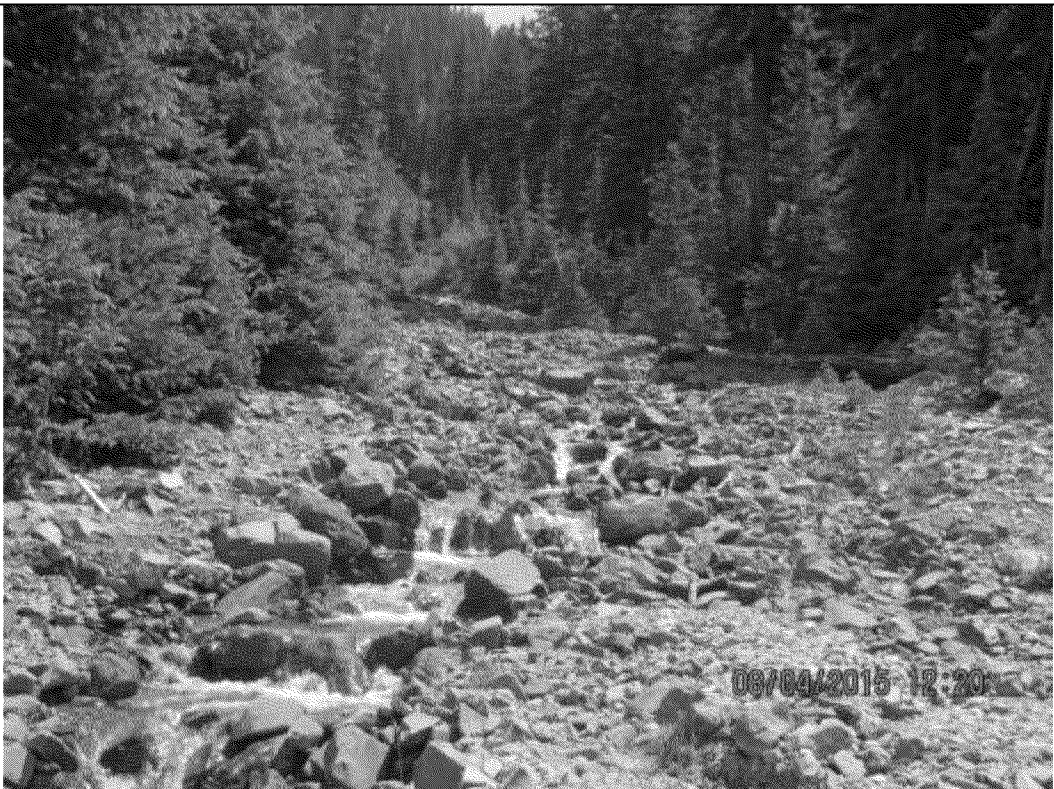
<p><b>Direction Photo Taken:</b></p> <p>Northeast</p>		
<p><b>Description:</b> First signs of adit, support pillar with lagging.</p>		
<p><b>Photo No.</b> <b>10</b></p>	<p><b>Date:</b> 08/04/2015</p>

<p><b>Direction Photo Taken:</b></p> <p>East</p>		
<p><b>Description:</b> Water of the North Fork just upstream of Cement Creek.</p>

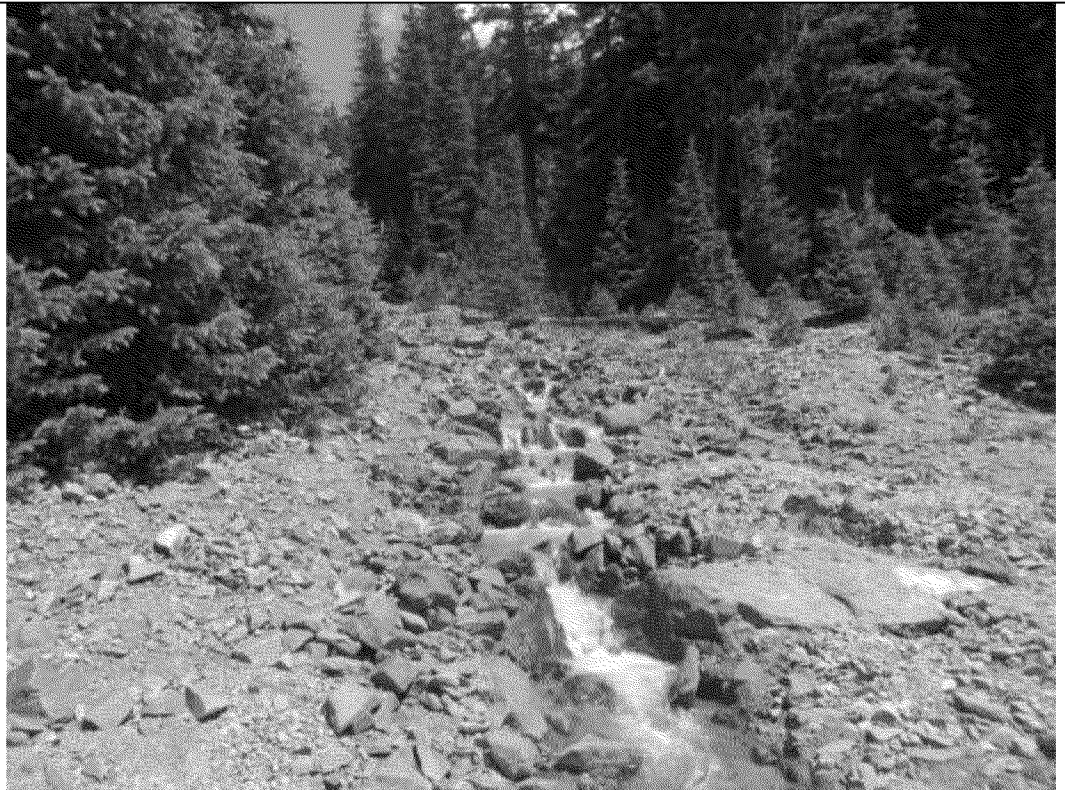
**Photo No.**  
**11**

Water of the North Fork just upstream of Cement Creek.

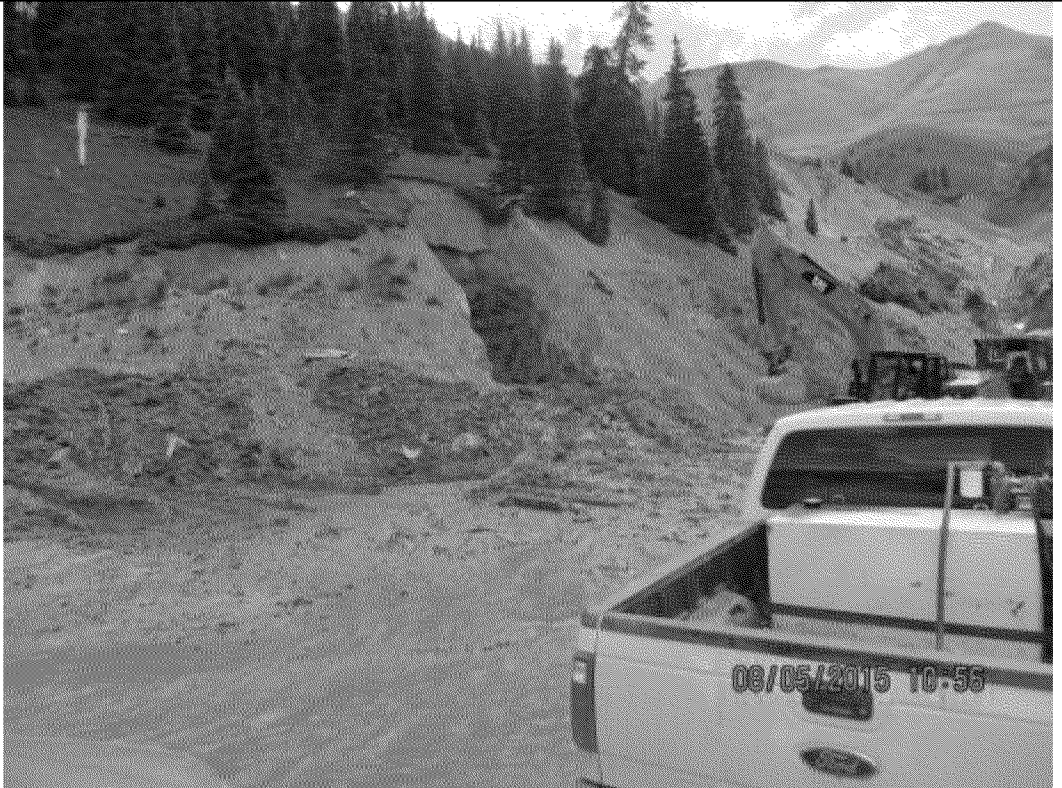
<b>Photo No.</b> 19	<b>Date:</b> 08/05/2015

<b>Direction Photo Taken:</b>  Northeast		
<b>Description:</b>  Adit flow increasing.		
<b>Photo No.</b> 20	<b>Date:</b> 08/05/2015

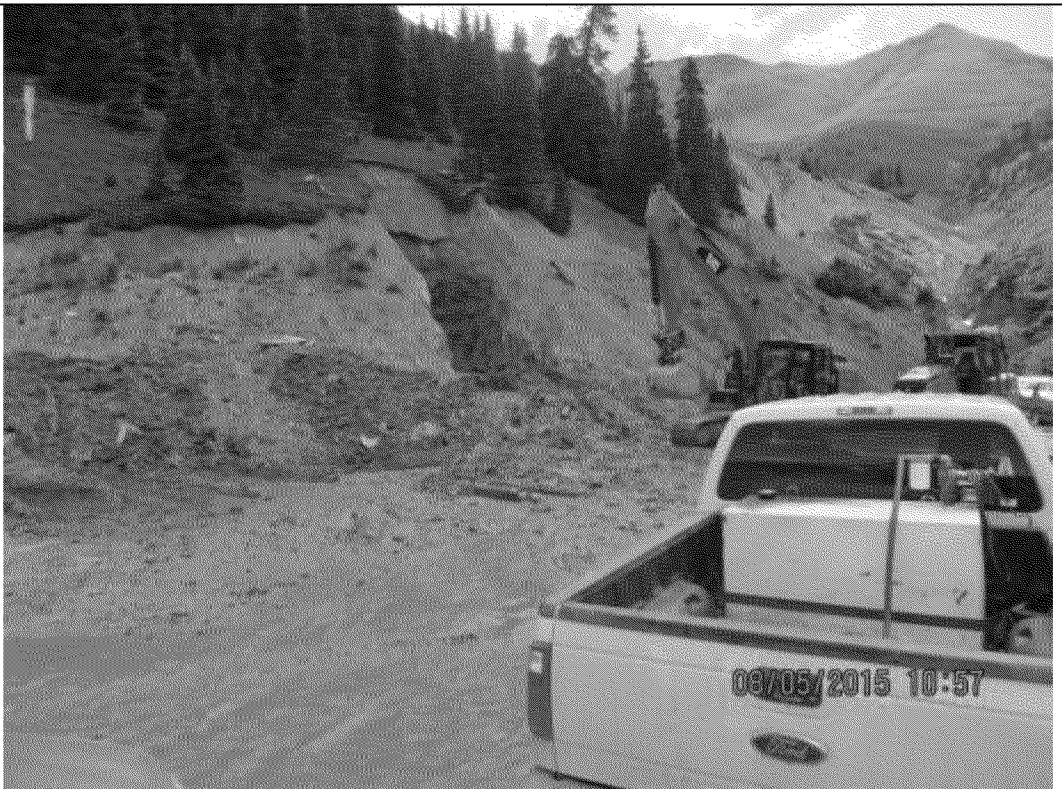
<b>Direction Photo Taken:</b>  Northeast		
<b>Description:</b>  Water flooding out at increased rate.

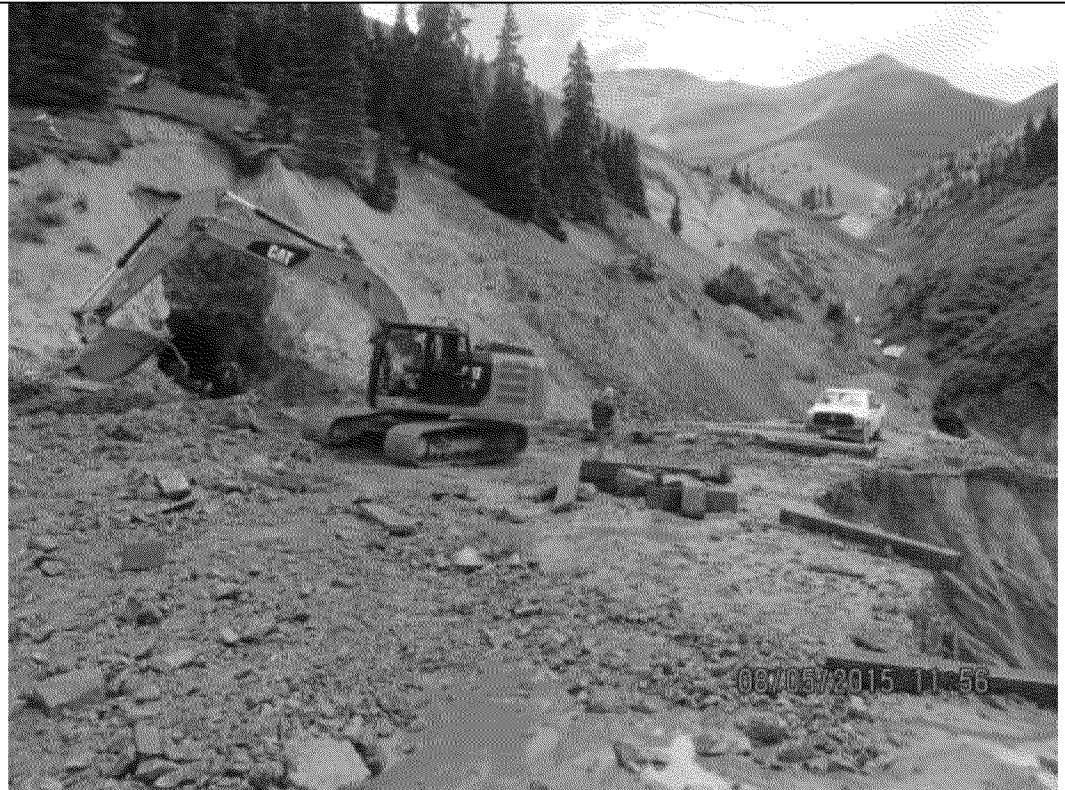
**Photo  
No.  
29**

Excavator redirecting  
water into existing half-  
pipe channel.

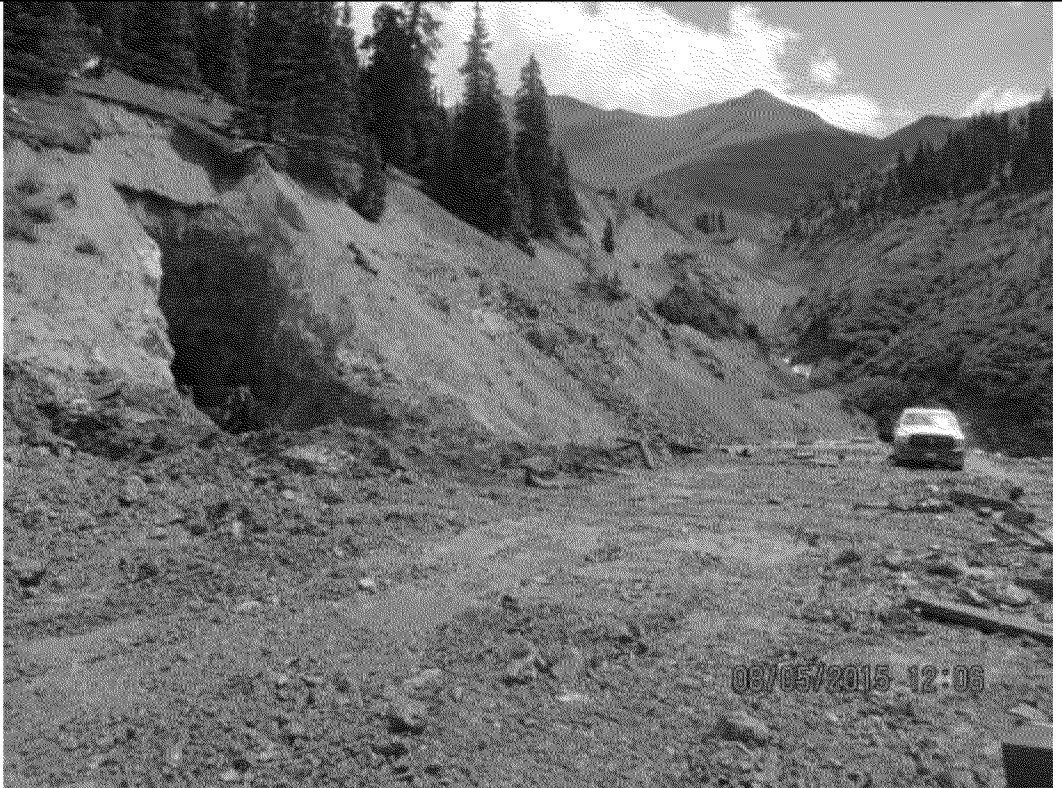
<b>Photo No.</b> 31	<b>Date:</b> 08/05/2015

<b>Direction Photo Taken:</b>  Northeast		
<b>Description:</b> Adit area after regrading.		
<b>Photo No.</b> 32	<b>Date:</b> 08/05/2015

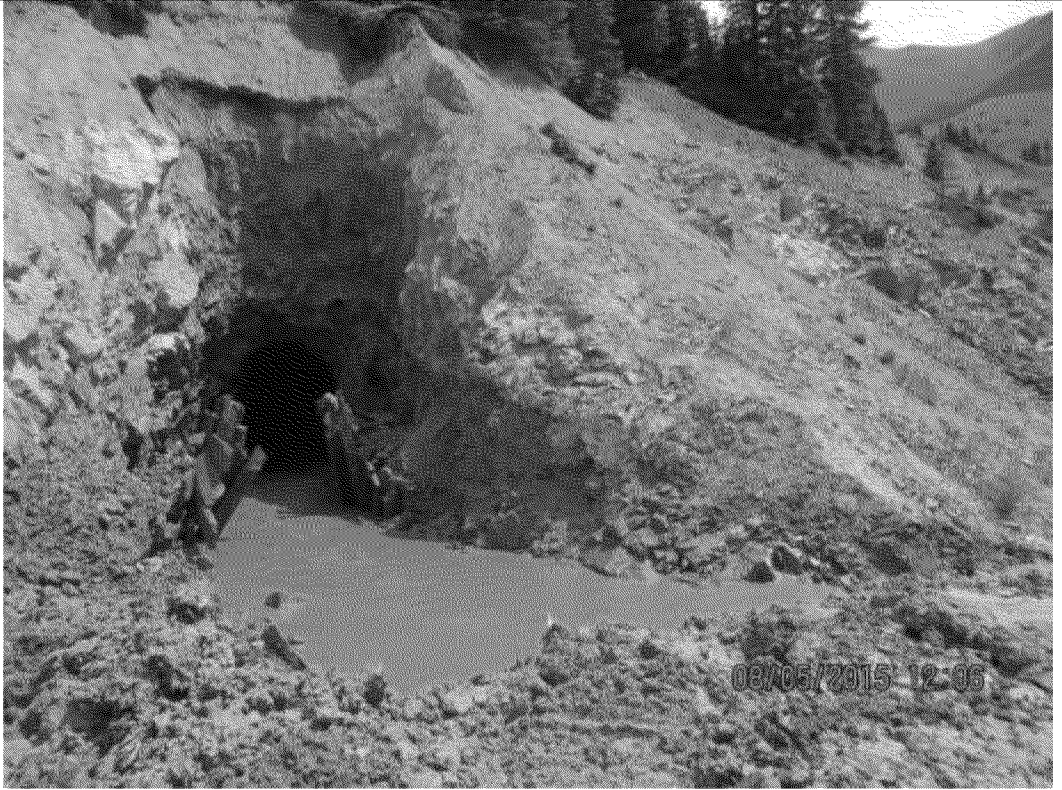
<b>Direction Photo Taken:</b>  North		
<b>Description:</b> Exposed adit and redirected flow, flow is beginning to subside.

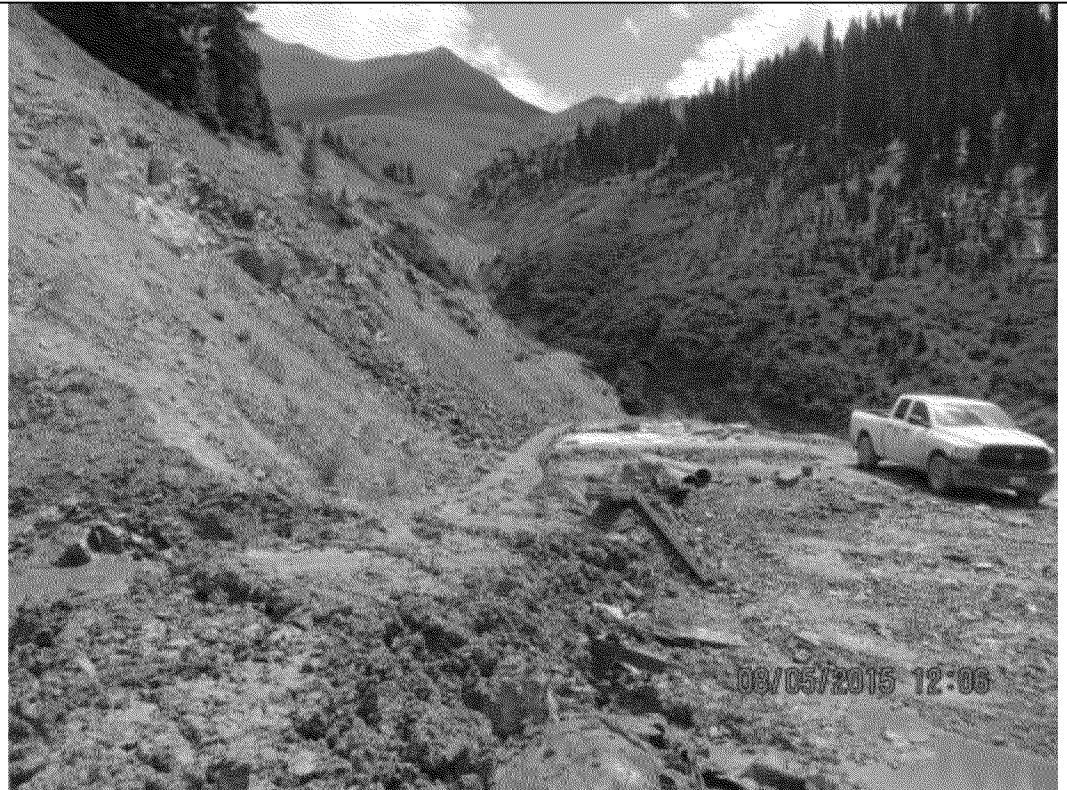
**Photo No.**  
**33**

Redirected flow into existing half culvert channel.

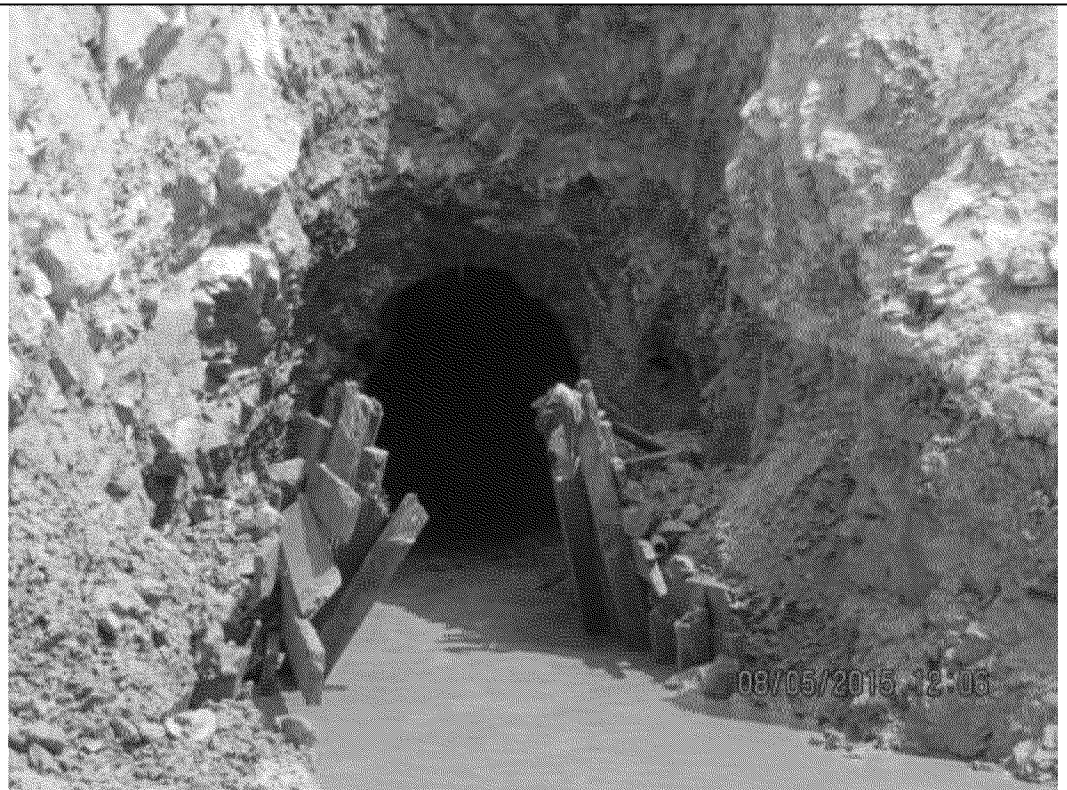
**Photo No.**  
**34**

Closeup of adit.

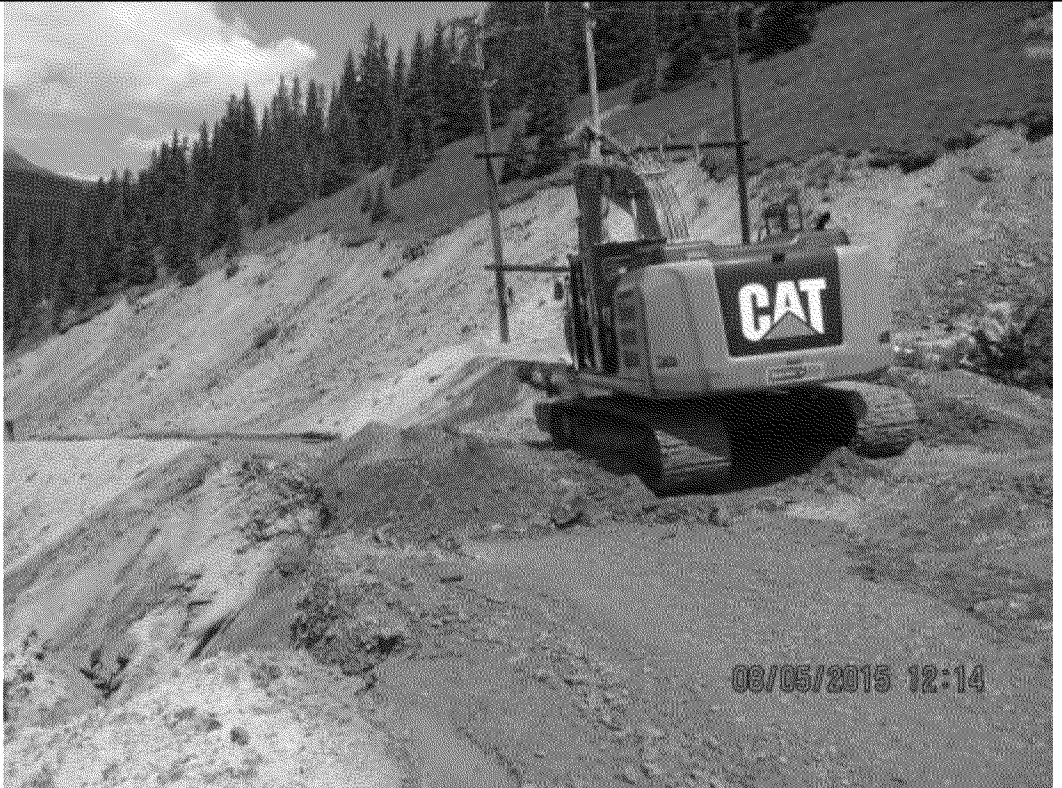
<b>Photo No.</b> 35	<b>Date:</b> 08/05/2015

<b>Direction Photo Taken:</b>  West		
<b>Description:</b> Excavator beginning work to secure safe exit route for equipment, vehicles, and personnel.

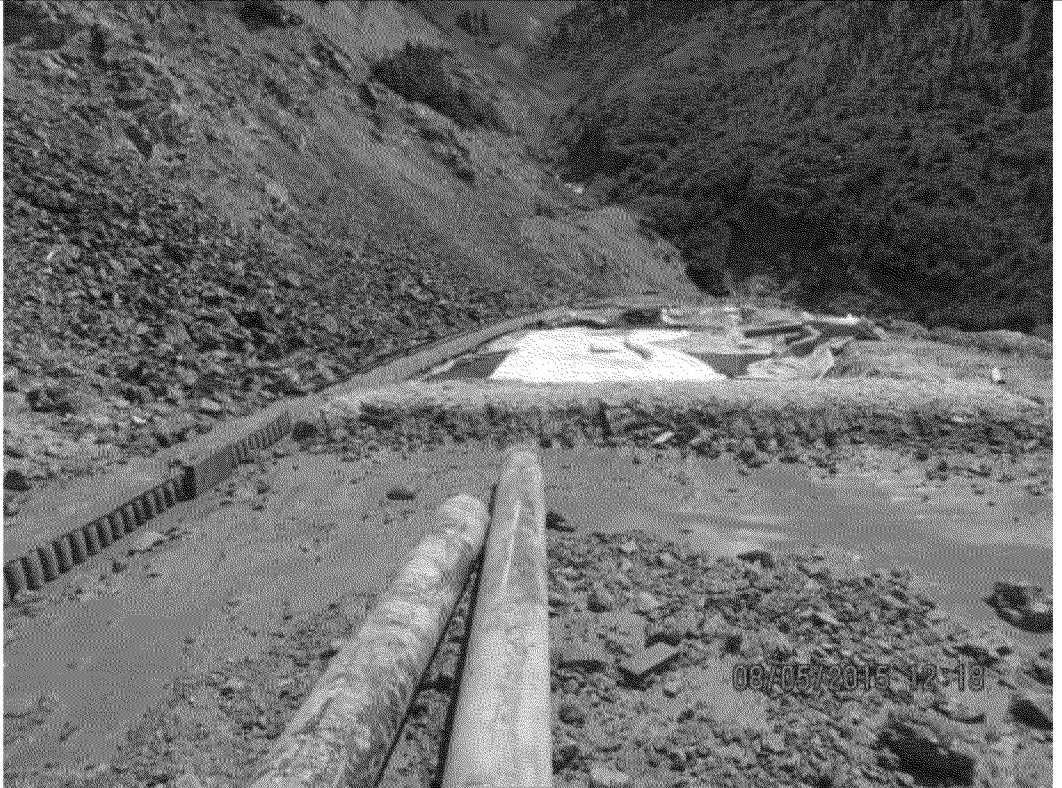
<b>Photo No.</b> 36	<b>Date:</b> 08/05/2015

<b>Direction Photo Taken:</b>  East		
<b>Description:</b> Existing flow channel at maximum capacity.

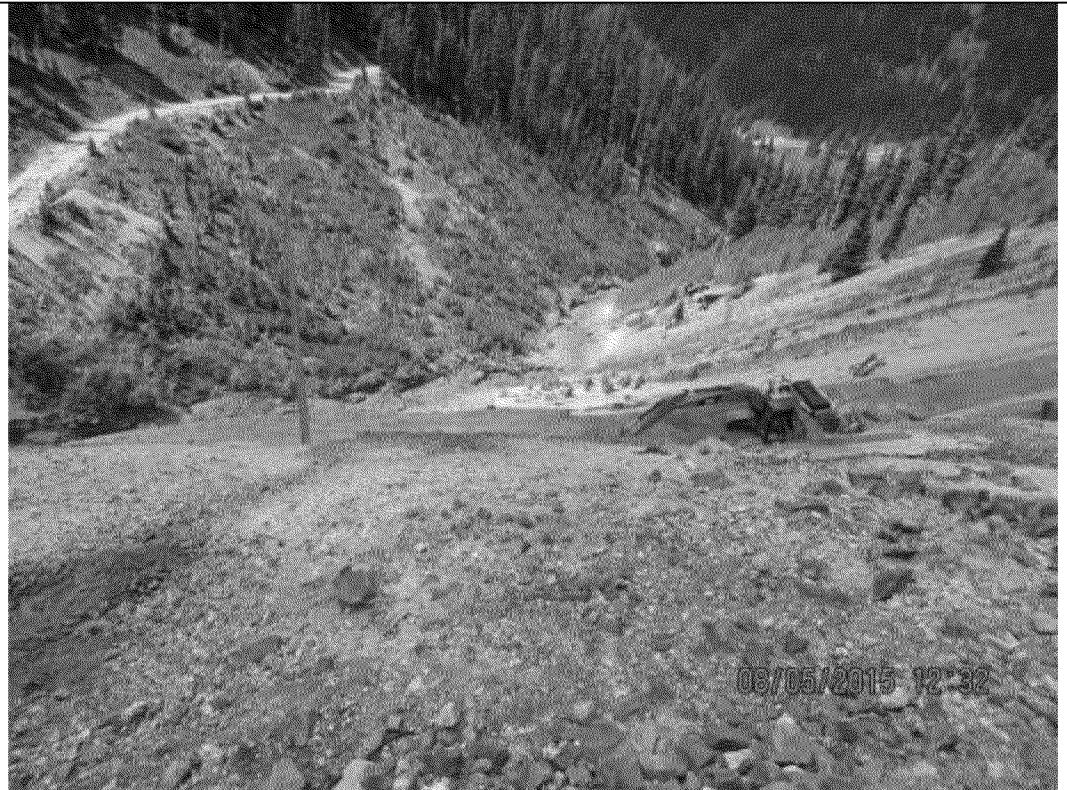
**Photo No.**  
**37**

Excavator progress on fixing access road to create a safe exit route.

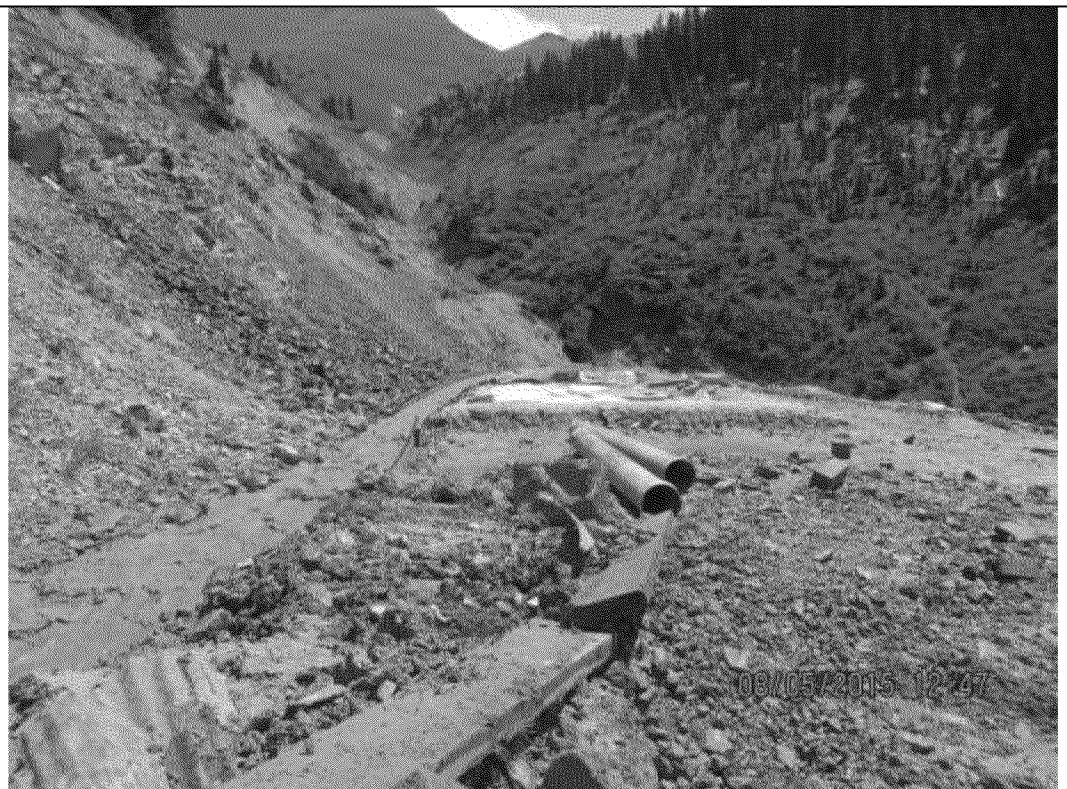
**Photo No.**  
**38**

Existing culvert flows subsiding minimally.

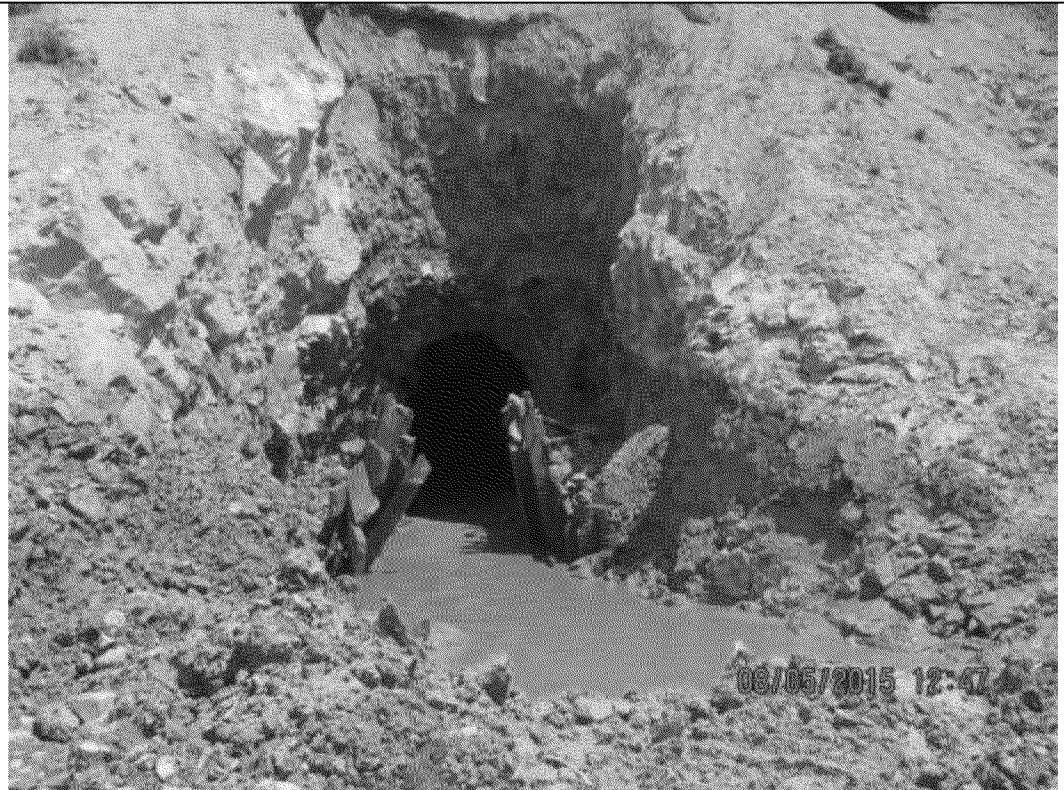
**Photo No.**  
**39**

No changes visible in adit structure or supports. Sloughing of materials inside the mine can be heard.

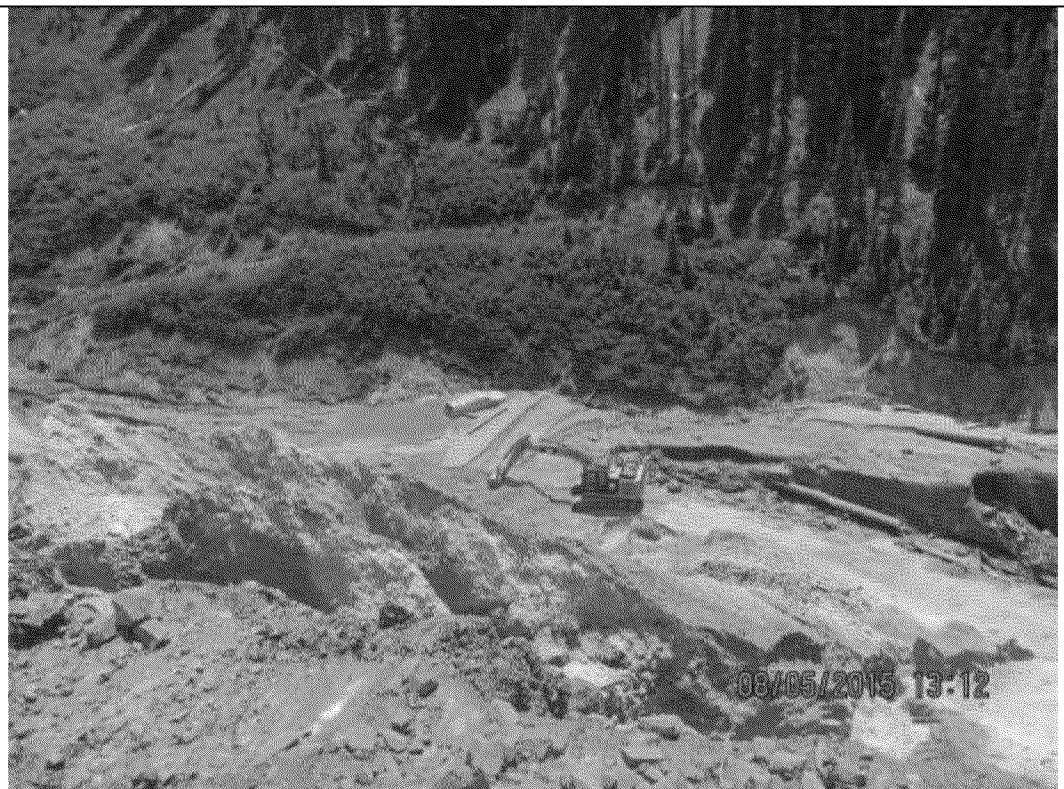
**Photo No.**  
**40**

Excavator progresses to washed out North Fork crossing.

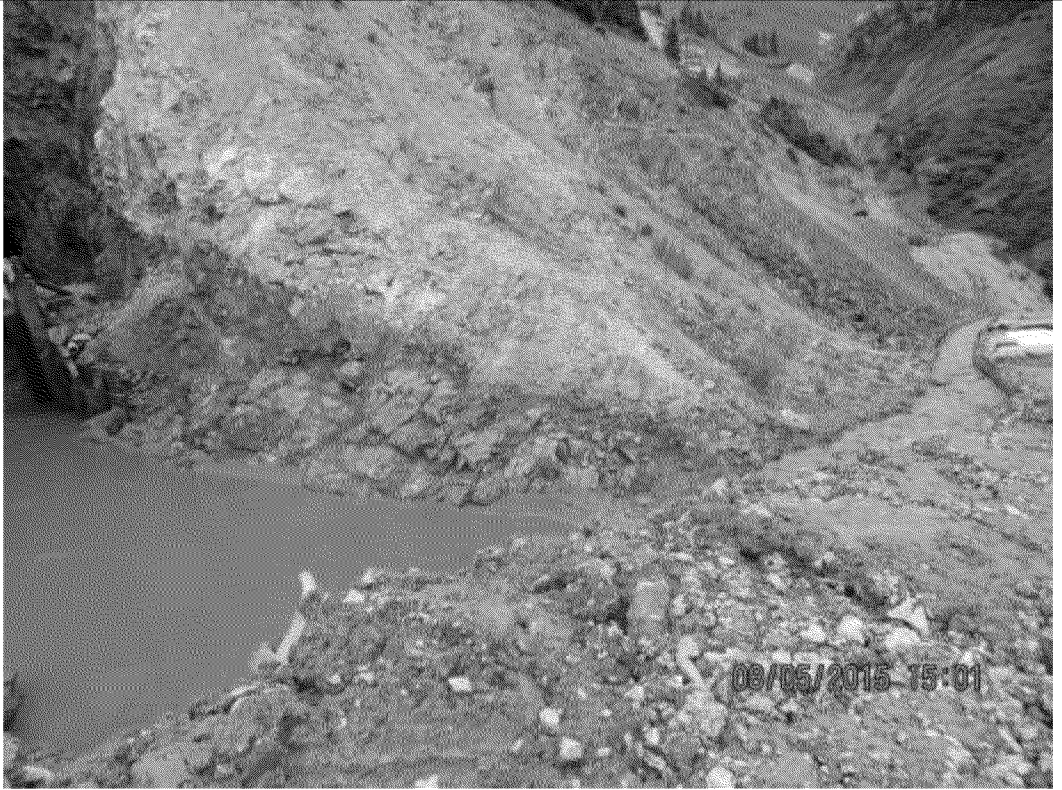
<b>Direction Photo Taken:</b>  Northeast		
<b>Description:</b> Flow path from adit, water flow appears to have stabilized around 1400.

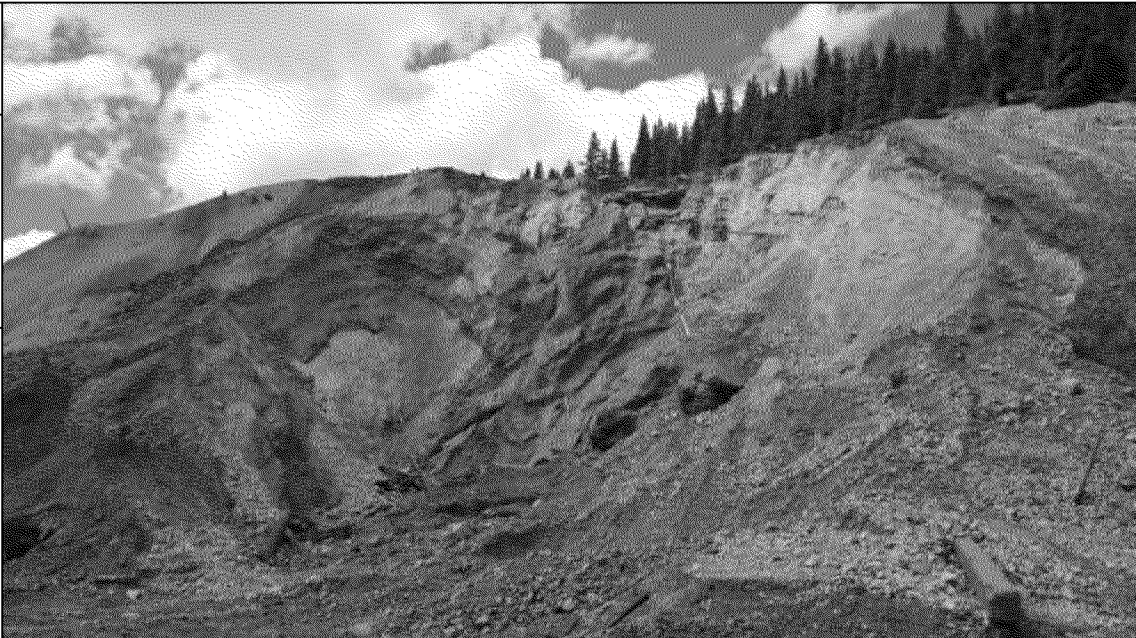
<b>Photo No.</b> <b>51</b>	<b>Date:</b> 08/05/2015

<b>Direction Photo Taken:</b>  North		
<b>Description:</b> Looking up from the toe of the Gold King waste dump directly south of the adit.		
<b>Photo No.</b> <b>52</b>	<b>Date:</b> 08/05/2015

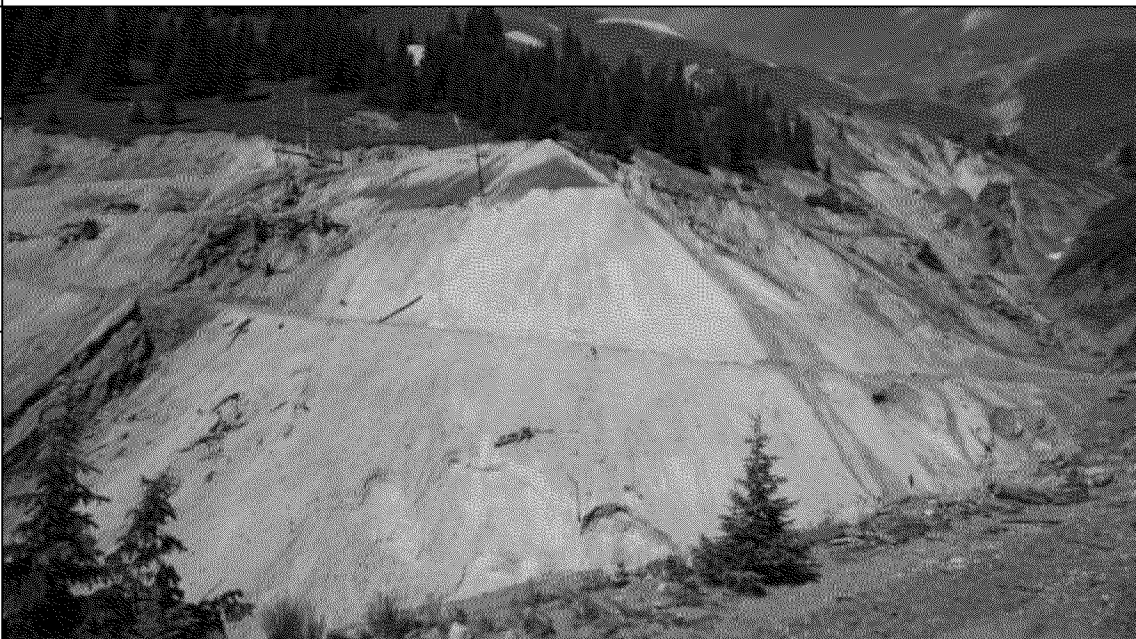
<b>Direction Photo Taken:</b>  Northeast		
<b>Description:</b> Gold King Mine tailings dump after water discharge.
